BUREAU OF SHIPS GROUP  
TECHNICAL INSPECTION REPORT

⑥ OPERATION CROSSROADS.  
U.S.S. GASCONADE (APA 85).

TEST BAKER.

VOLUME 1 [U] ⑧

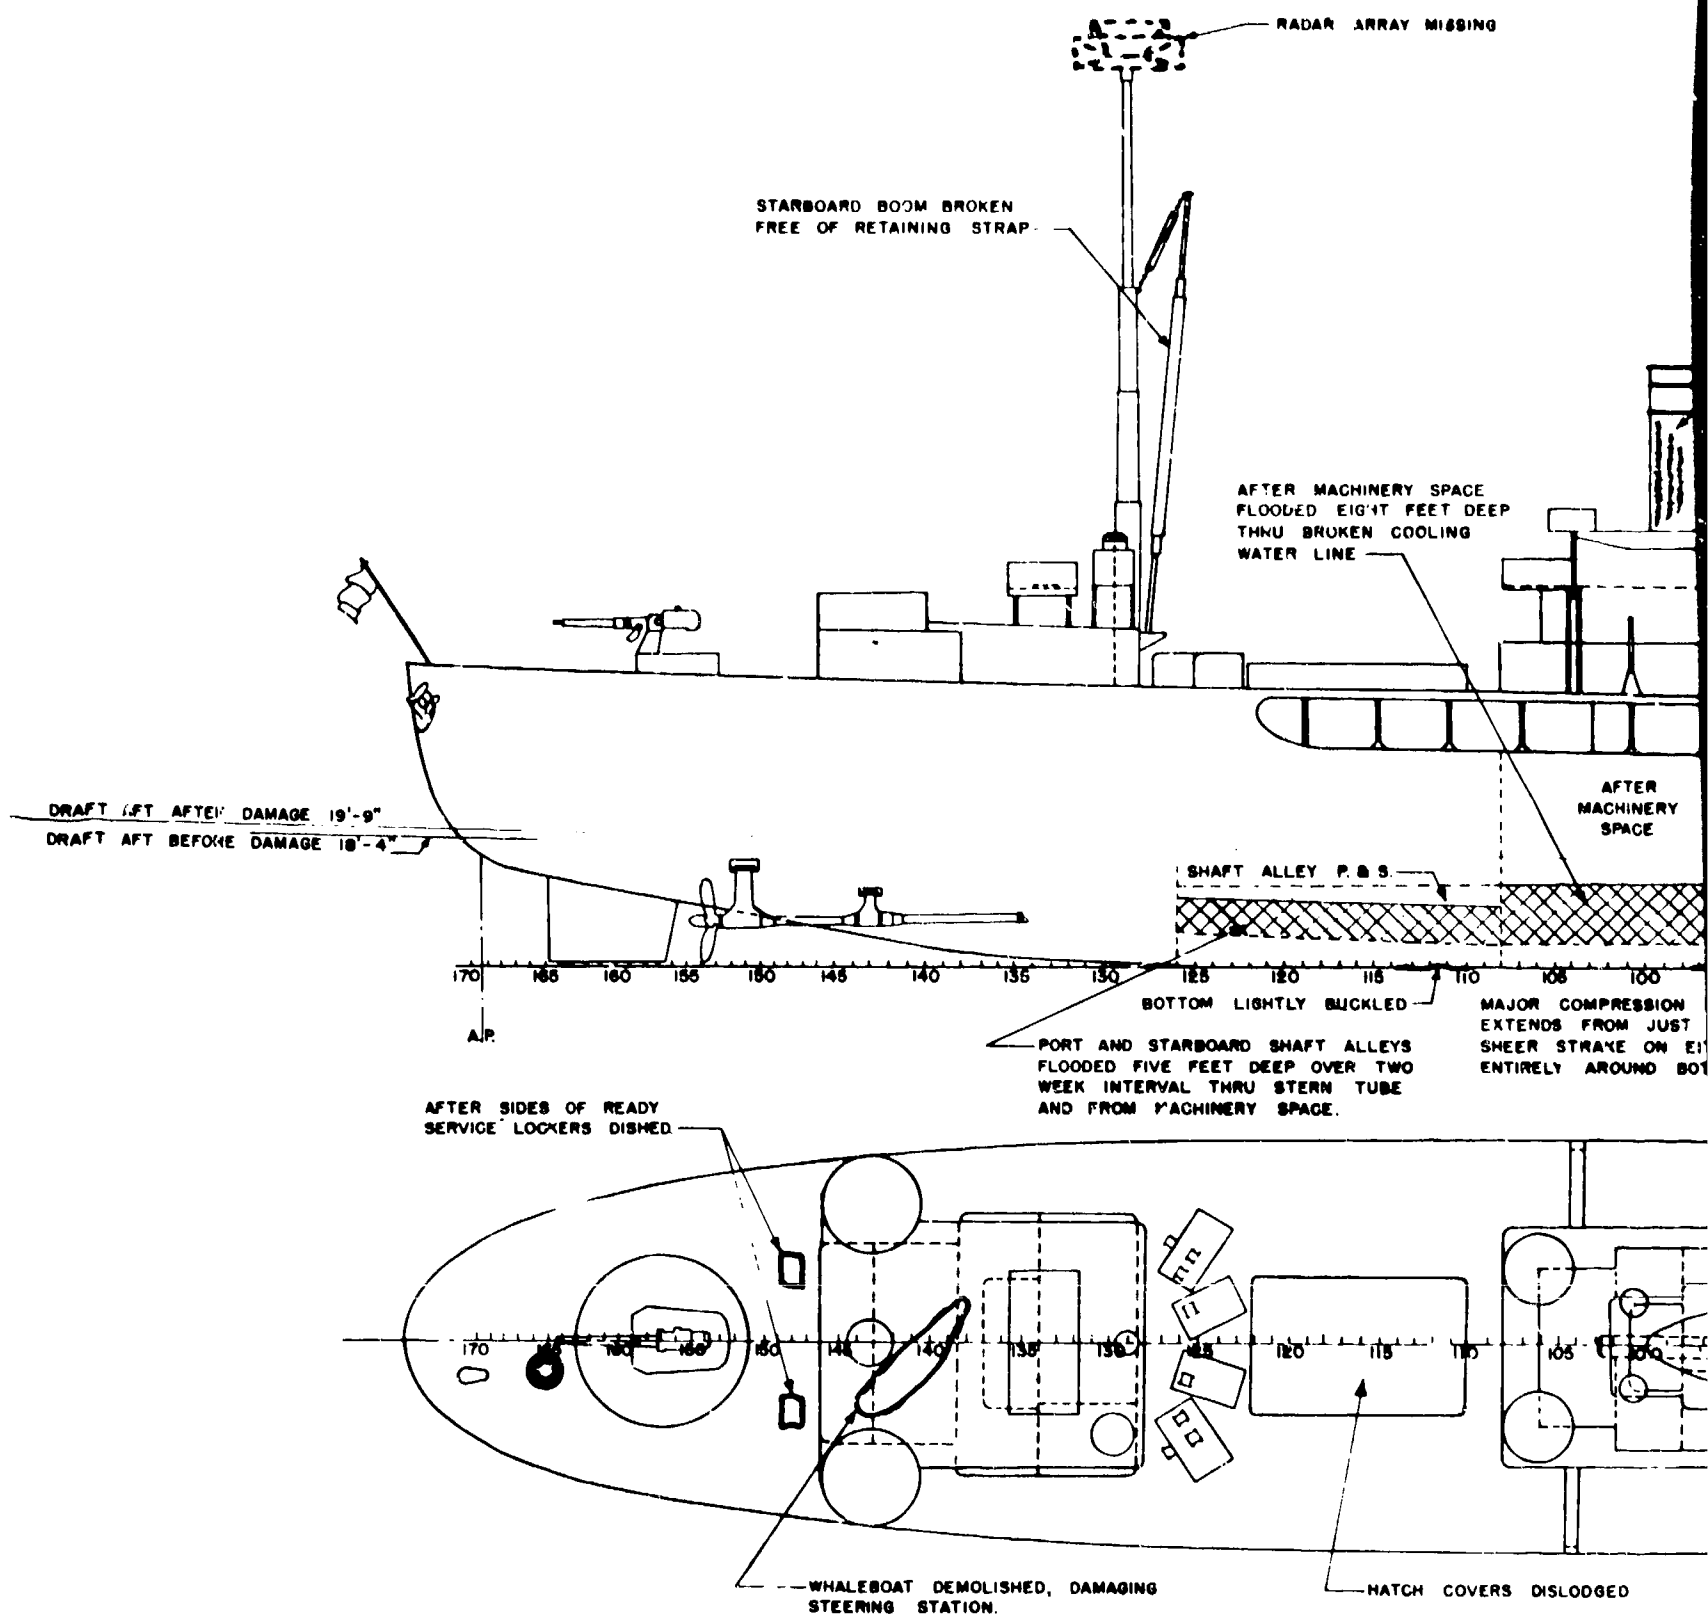
SHIP DAMAGE DIAGRAM

- (a) There was considerable damage from test B. The after engineering space and shaft alleys were flooded. Rigging was severed or loosened. Equipment and fittings had been torn off bulkheads and strewn about. The ship had buckled between frames 95 and 96 on both port and starboard sides. It is believed that all personnel would have been killed or seriously injured had they been on board. The ship was highly radioactive on first reboarding.
